Geologic Assessment

Regulated Entity Name: Village at Gruene Condominiums

| GEOLOGIC ASSESSMENT TABLE | | | | | | PROJECT NAME: Village at Gruene Condominiums - New Braunfels, Comal County, Texas (RKI Project No. ASF19-124-00) | | | | | | | | | | | | | | |

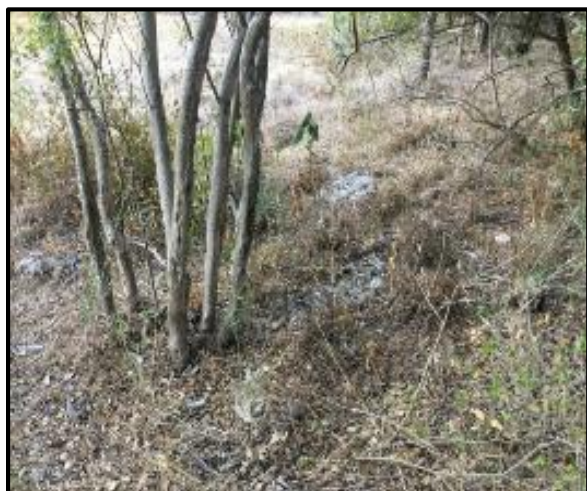
Feature S-1 (SF):

Feature S-1 consists of solution-enlarged fractures in a limestone outcrop measuring approximately 15 x 10 feet in plan view. The photograph depicts the outcrop and fractures. This feature is located in the southwest portion of the property on a slight break-in-slope formed by erosion. The limestone exposure is generally consistent along the 665 foot elevation contour interval. The orientation of the fractures shown are approximately 340° (N-S). Fracture density and apertures are approximately 1.5 feet and 0.1 feet, respectively.

ON-SITE Feature S-1 consists of a weathered limestone exposure exhibiting dissolution-enlarged fractures. Fractures, which trend roughly north-south, are apparently limited to the upper limestone bedding unit and were found to extend about 1 foot vertically into the subsurface, terminating in a lower limestone bedding unit. The feature is partially filled with fine-grained soils and vegetative materials. Exposed bedrock in the area containing the subject feature generally meets the definition of “karren”. This is supported by the fact that dissolution features generally terminate in soil or the uppermost limestone bedding unit with no connection to the subsurface that would provide rapid infiltration.

This feature is classified as not sensitive owing to its erosional origin, stratigraphic location, and estimated low relative infiltration rate (i.e., no evidence of capacity for rapid infiltration).

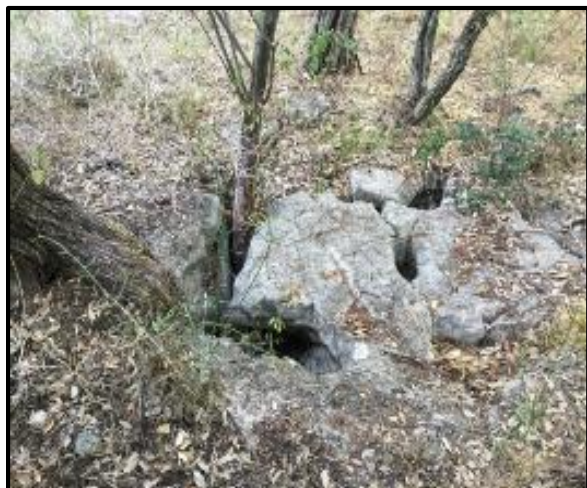
Feature S-2 (SC):

Feature S-2 consists of a solution cavity formed by dissolution of limestone bedrock likely associated with tree root growth. The dimensions of this feature are approximately 6 x 4 x 1.5 feet in length, width and depth, respectively. Orientation of the long axis of this feature is approximately 310° (NW-SE). There was no apparent development of drainage towards this feature that would indicate potential recharge at this location.

ON-SITE Feature S-2 consists of a solution cavity that appears to have formed as the result of tree root activity. The feature consists of small vertical solution cavities associated with surface scour and erosion within the weathered upper surface of the Person Formation. The feature is primarily limited to the soil zone, but were found to extend about 1.5 feet vertically into the subsurface based on probing through loose soil infilling. The feature appears to have been enhanced by tree root activity and surface runoff. Collective field observations indicate that the feature is limited to the uppermost weathered limestone/soil horizon (epikarst zone) and does not connect to a larger subsurface karst features or open void.

This feature is classified as not sensitive owing to its inferred erosional origin, position within the epikarst zone with no connection to underlying limestone, and estimated low relative infiltration rates (i.e., no evidence of capacity for rapid infiltration).

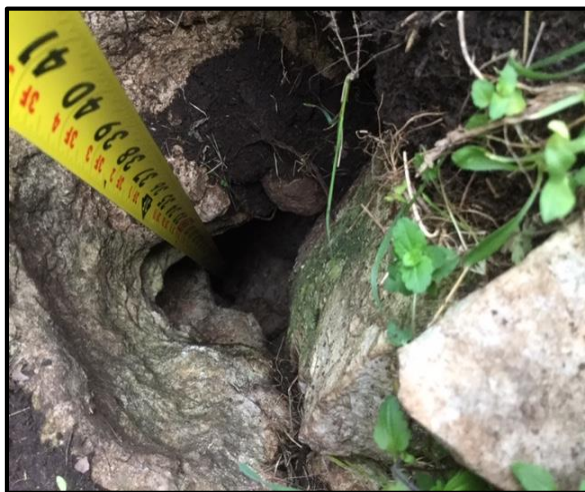
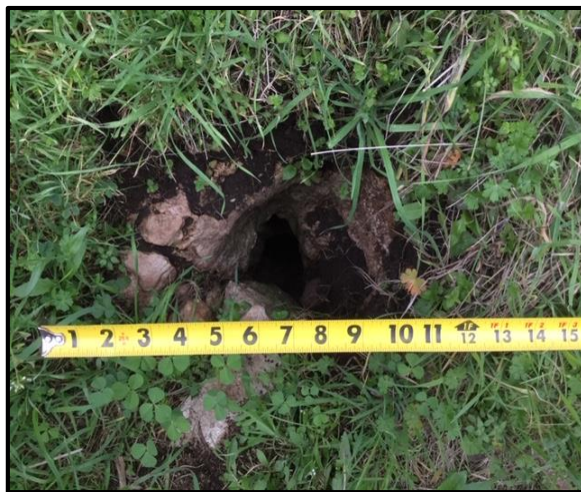
Feature S-7 (SC):

Feature S-7. As discussed in the previous geologic assessment (GA) report that was submitted for the project on February 5, 2020, a vertical solution cavity was recently identified at the SITE in close proximity to the proposed sanitary sewer utility. At the time the feature was initially assessed, its dimensions were measured at approximately 1 x 0.8 x 4 feet in length, width and depth, respectively. Although the feature was essentially vertical, the orientation of its long axis was approximately 347° (NW-SE). Based on limited hand excavation and probing, the feature was observed to taper with depth, but it was not possible to determine its complete vertical extent. Surface soil with grass was present at the base of the feature, which confirmed recent collapse. No air flow from the feature or defined surface drainage toward the feature was observed.

Pursuant to our subsequent discussions with TCEQ following their review of the previous GA report and in accordance with Edwards Aquifer Protection Program (EAPP) requirements and conditions set forth in the approved work plan submitted electronically to the agency on February 12, 2020, feature excavation activities were conducted on February 18, 2020 using heavy equipment. Excavation activities were conducted to evaluate whether a significant hydrologic connection to the subsurface existed at this location (i.e., feature serves to transmit recharge directly to the subsurface). Subsurface exploration activities were conducted to further assess the sensitivity of the feature and potential for connection to a larger subsurface void space.

The original vertical solution cavity was fully removed as the result of excavation activities. The bedding contact at its termination point was observed to be highly weathered, with iron-staining and evidence of dissolution along the upper surface of the underlying (less resistant) limestone unit. The majority of the dissolution openings throughout this zone of weathering were partially to completely infilled with red “terra rossa” clay soil with scattered tree roots. The feature was found to terminate at the bedding contact and did not exhibit direct connection to any larger karst openings or void space.

not possible to determine its complete vertical extent. Surface soil with grass was present at the base of the feature, which confirmed recent collapse of soil cover. As reported in the previous February 5, 2020 GA report, this feature was initially classified as potentially sensitive owing to its inferred karst origin, connection to underlying limestone, and inferred potential for rapid infiltration. Although classified as sensitive per point assignment criteria set forth in the Geologic Assessment Table, it was not considered to represent a significant recharge feature, however, owing to its small size, lack of established drainage, and very small upgradient catchment area.

- The solution cavity appears to have been formed in association with surficial erosional processes and tree root activity. Tree roots were encountered during the excavation process.
- The feature was found to terminate at the bedding contact and did not exhibit direct connection to any larger karst openings or subsurface void space.
- Although the bedding contact was observed to be highly weathered, with iron-staining and evidence of dissolution, the majority of the dissolution openings throughout this zone of weathering were partially to completely infilled with red “terra rossa” clay soil and scattered tree roots.
- There is no well-defined drainage or channelization of surface flow to the feature. The feature did not contribute significant recharge to the subsurface.

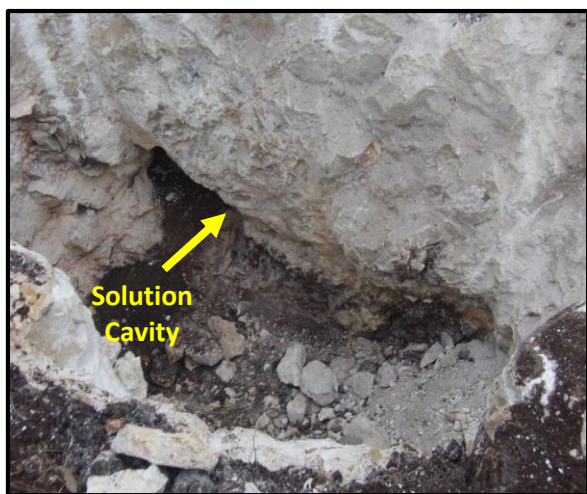
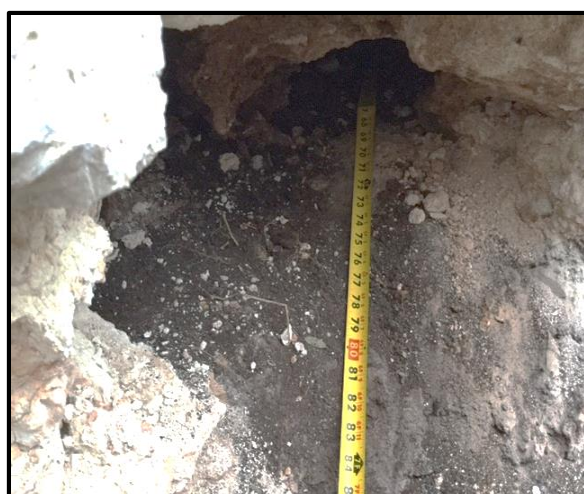
Feature S-8 (SC):

Feature S-8. In conjunction with vertical excavation efforts that extended slightly (i.e., 1-2 feet) below the termination point for Feature S-7 through the weathered bedding-unit contact zone, a separate horizontal void space (solution cavity) was observed at the northwest corner of the excavation. As depicted on **Figure 1** and annotated photographs provided immediately following this **Comments** section, the aperture was measured at approximately 21 x 14 inches and confirmed to extend approximately 7 feet along the contact zone at an orientation of 29° (NE-SW). No direct connection to Feature S-7 was observed. The horizontal solution opening was not observed to connect to the south or west excavation walls and appears to represent void space along the bedding contact zone (i.e., area not completely infilled by clay terra rossa soils). The floor of the horizontal solution cavity area was observed to be comprised of clay soils. The thickness of the soils along the bedding contact is estimated to be about 1.5 to 2 feet based on excavation activities within the exploration trench.

The solution cavity opening was directly observable with the aid of a flashlight and found to taper with distance away from the excavation site (trench). The lateral boundaries of the solution cavity area are irregular and comprised of weathered (in-place) limestone and terra rossa clay. The feature was found to terminate at a distance of 7 feet. No air flow from the feature was observed and interior conditions were observed to be dry to moist. As tree roots were present within the solution cavity void space and surrounding walls, it appears that the feature (and the larger bedding unit contact zone) has been exploited historically by tree root activity.

ON-SITE Feature S-8. In conjunction with vertical excavation efforts that extended slightly (i.e., 1-2 feet) below the termination point for **Feature S-7** through the weathered bedding-unit contact zone, a separate horizontal void space (solution cavity) was observed at the northwest corner of the excavation trench. As depicted on the field sketches and annotated photographs provided in the **Comments** section, the aperture was measured at approximately 21 x 14 inches and confirmed to extend approximately 7 feet along the contact zone at an orientation of 29° (NE-SW). The feature is localized in nature and does not connect to the south or west

excavation walls. The floor of the horizontal solution cavity area was observed to be comprised of clay soils. The thickness of the soils along the bedding contact is estimated to be about 1.5 to 2 feet based on excavation activities within the exploration trench. The solution cavity opening was directly observable with the aid of a flashlight and found to taper with distance away from the excavation site (trench). The lateral boundaries of the solution cavity area are irregular and comprised of weathered (in-place) limestone and terra rossa clay.

- Prior to excavation, this horizontal solution opening did not have a direct connection to the surface. No direct connection to **Feature S-7** was observed.

- The solution cavity is localized and appears to have been formed by dissolution along the limestone bedding-unit contact zone. The contact zone that hosts the feature is partially to completely infilled with red terra rossa clay soils, which typically facilitate the retention of subsurface soil moisture.

- The feature was found to terminate at a maximum distance of 7 feet from its opening. No air flow from the feature was observed and interior conditions were observed to be dry to moist. The feature does not constitute a drain and is not considered to represent a major component of the subsurface flow system.

- On the basis of Phase II assessment results discussed herein, it is recommended that the WPAP include provisions for the plugging and abandonment of the exploratory trench that was installed

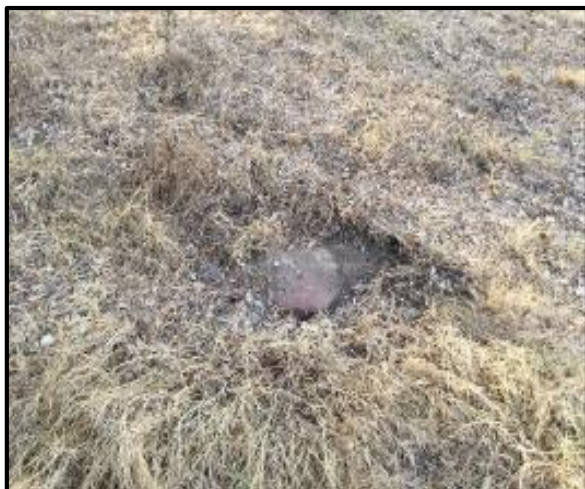
Feature S-3 (MB):

Feature S-3 is a derelict septic system measuring approximately 10 x 5 feet in plan view. The apparent concrete tank is installed to at least 5 feet into the Person Formation. This manmade feature is located in the southeast portion of the property, approximately 50 feet southeast of the former residential structure. No septic discharge features (i.e., sprinkler heads) or apparent subsurface leach field were observed. No surface expression of preferential flow towards this feature was observed during SITE reconnaissance activities.

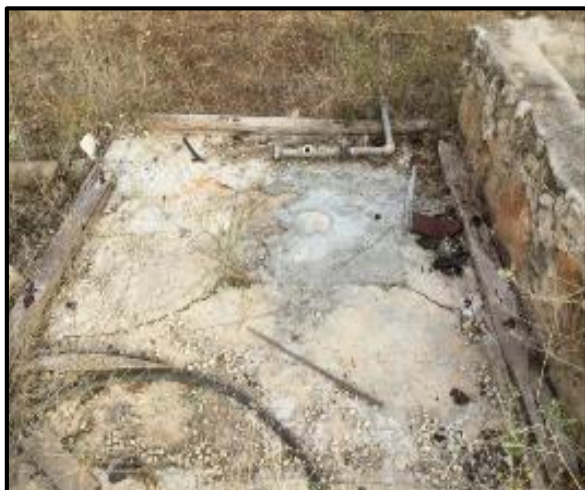
Feature S-4 (MB)

Feature S-4 is a plugged domestic water-supply well. The wellhead is located in the south central portion of the property approximately 100 feet west of a former residential structure. Research in the Texas Water Development Board (TWDB) Well Registration Database confirms that the well (State Well No. 6824106) was drilled in 1936 to a total depth of 65 feet and is completed in the upper part of the Edwards Aquifer. Based on the State of Texas Plugging Report No. 176093, approximately 40 feet of well casing was removed and cemented from 68 feet to ground surface to plug the well on March 15, 2018. As reported on the well plugging report, a void was discovered at approximately 68 feet below ground

surface (bgs). The void was reportedly infilled with gravel from 68 to 98 feet bgs to facilitate plugging.

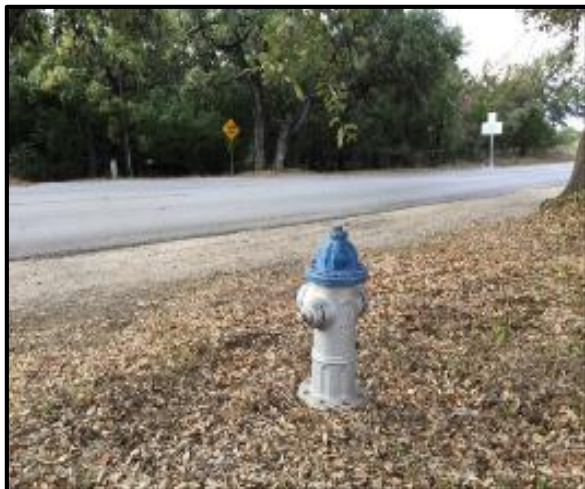
Feature S-5 (MB)

Feature S-5 consists of an existing potable water line. On the basis of our observations, it is inferred that the trench hosting the utility line is installed 4-6 feet or more into the Person Formation. Based on field reconnaissance and review of the Overall Wastewater Plan, dated October 2019 provided by HMT Engineering & Surveying, this trench hosts an existing 12- to 8-inch water line that runs parallel to Gruene Road. The water line has a tie-in connection near an existing fire hydrant just off the property boundary with a length within the off-site SCS project area estimated on the order of 411 linear feet.

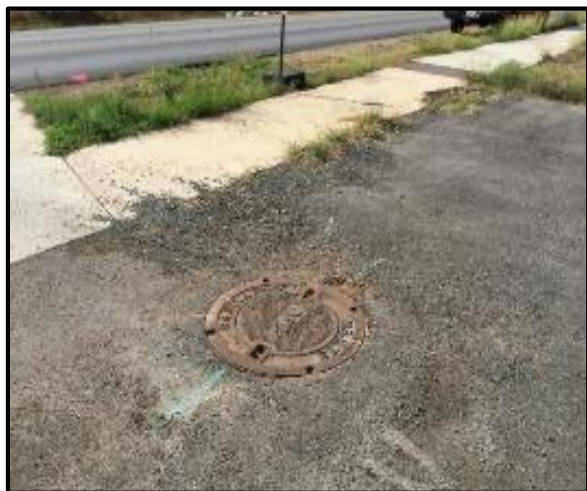
Feature S-6 (MB)

Feature S-6 consists of an existing 8-inch polyvinyl chloride (PVC) wastewater line. Based on field reconnaissance and review of the Overall Wastewater Plan, Sheet C8.5 (HMT, 2019) the trench hosting the utility line is installed 4-6 feet or more into the Person Formation. The wastewater line was identified by an existing manhole located approximately 284 feet southwest of the on-site property boundary corner. The wastewater line within the off-site SCS project area is estimated on the order of 50 linear feet.

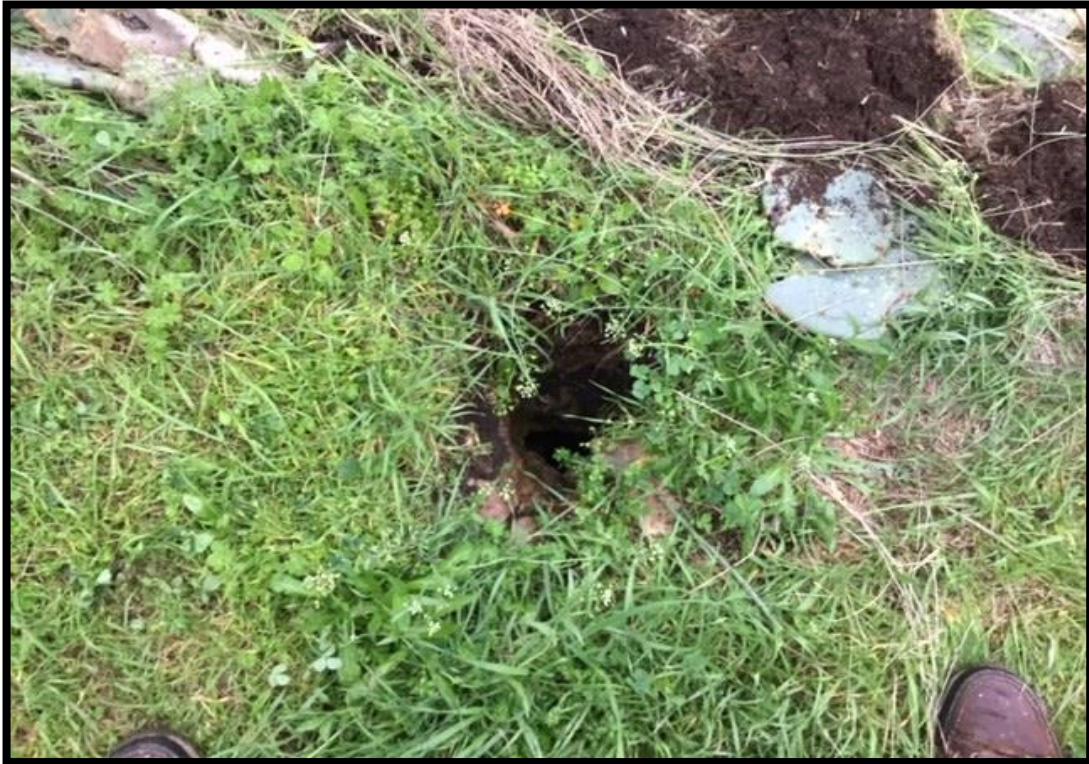
Photo 1. View of Feature S-7 prior to excavation. Feature size is approximately 1 x 0.8 x 4 feet in length, width, and depth, respectively.

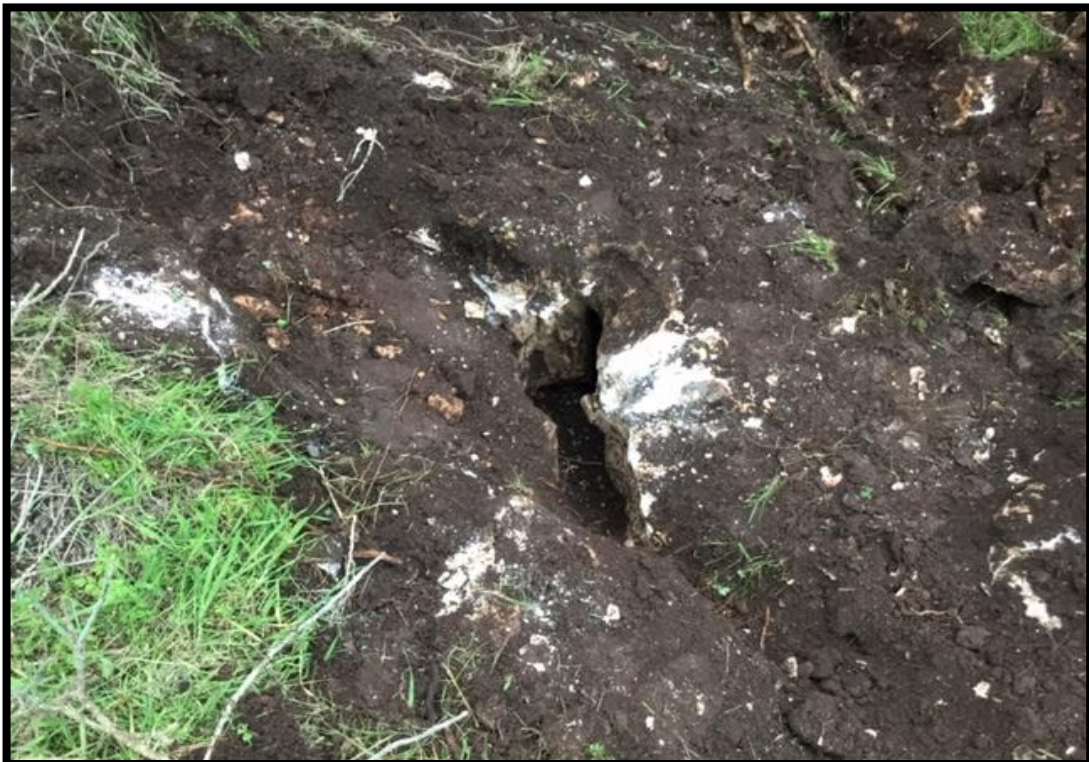
Photo 2. Top of limestone bedding unit at Feature S-7 following removal of soil and vegetation.

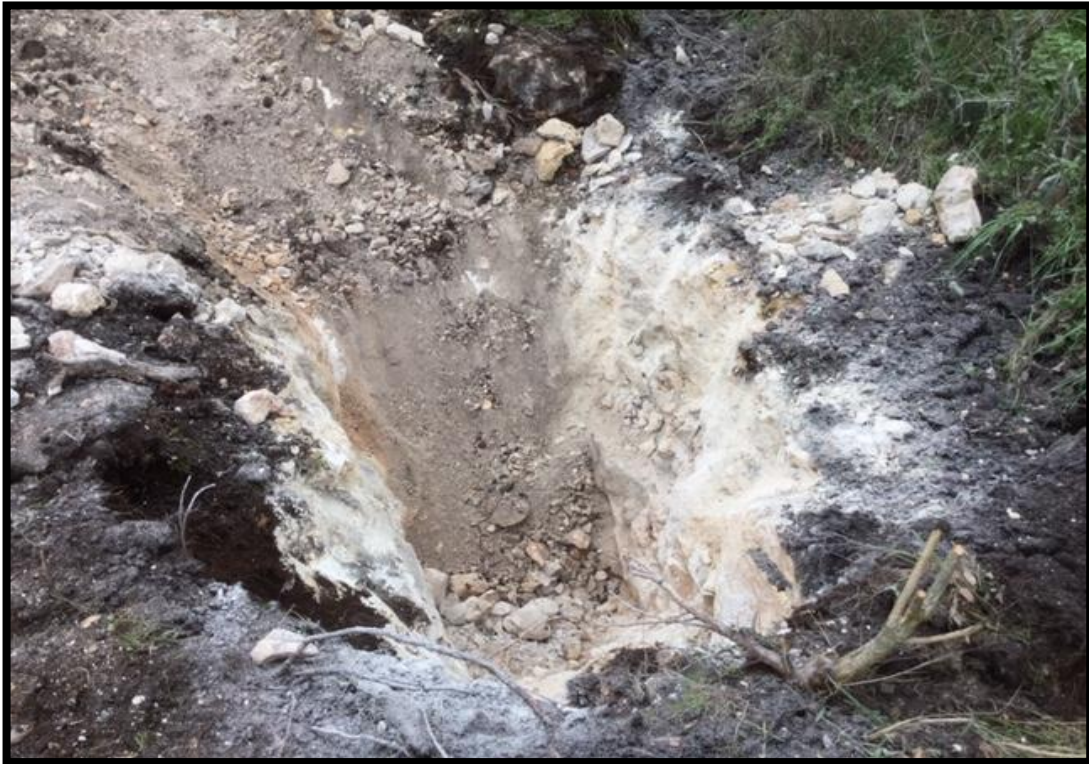
Photo 3. Excavation at Feature S-7 in progress through the resistant upper bedding unit of the Person Formation (Cyclic and Marine member).

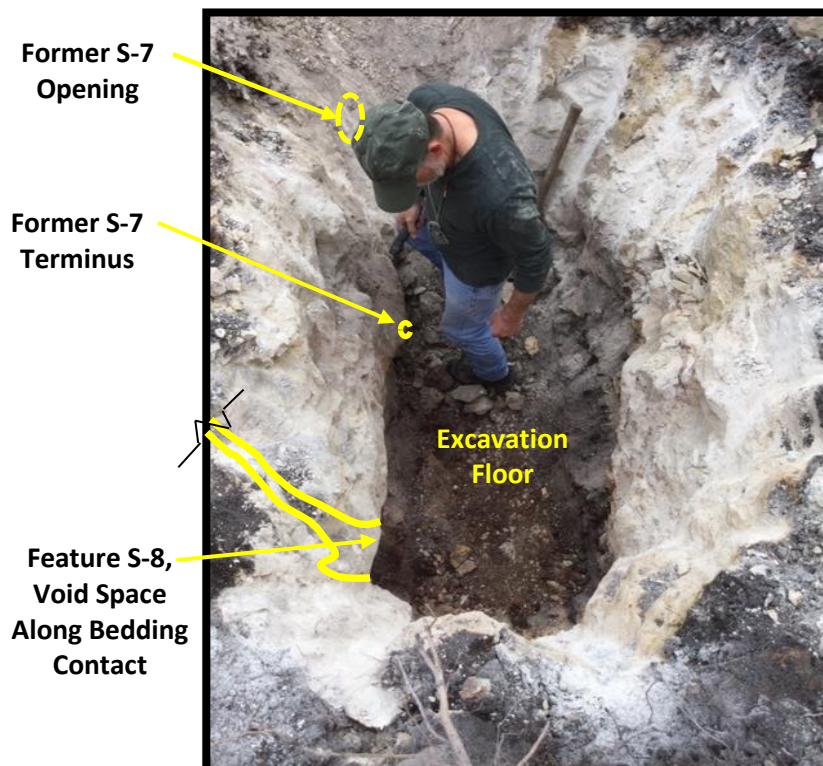
Photo 4. Final excavation extent. Feature S-7 is completely removed and was determined to be terminated at the weathered limestone contact zone (excavation floor).

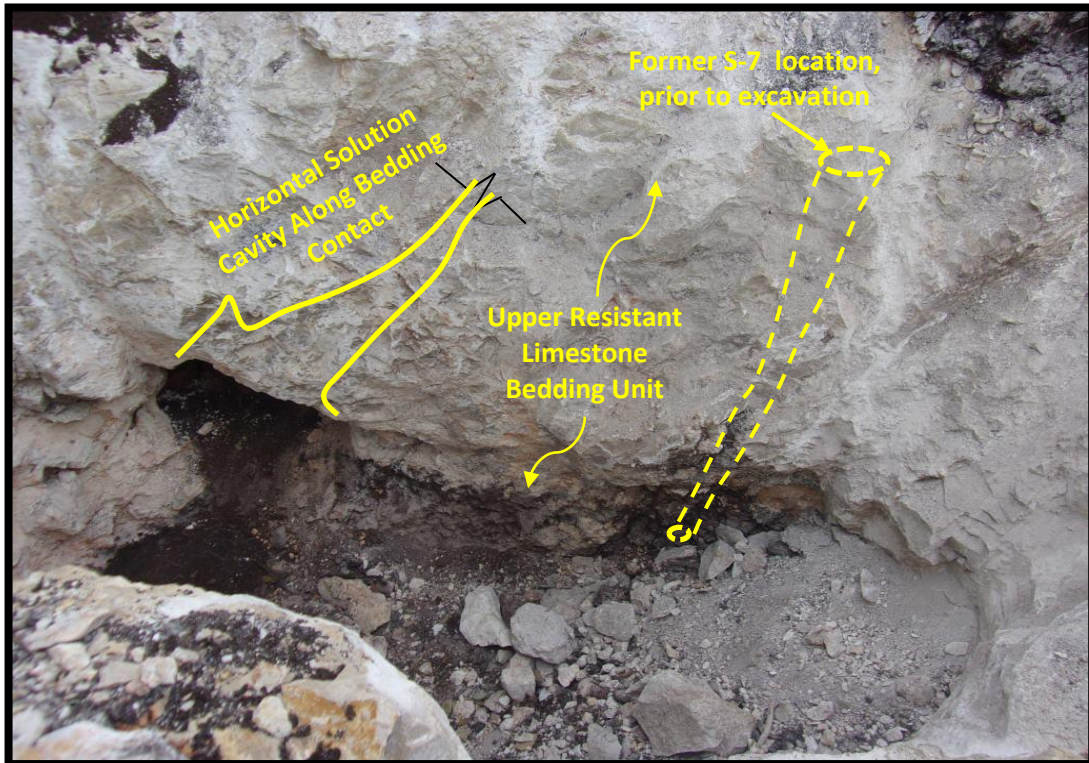
Photo 5. Overview of Feature S-8 opening at base of the bedding contact. Floor of the excavation consists of the weathered contact zone with abundant terra rossa clay infilling.

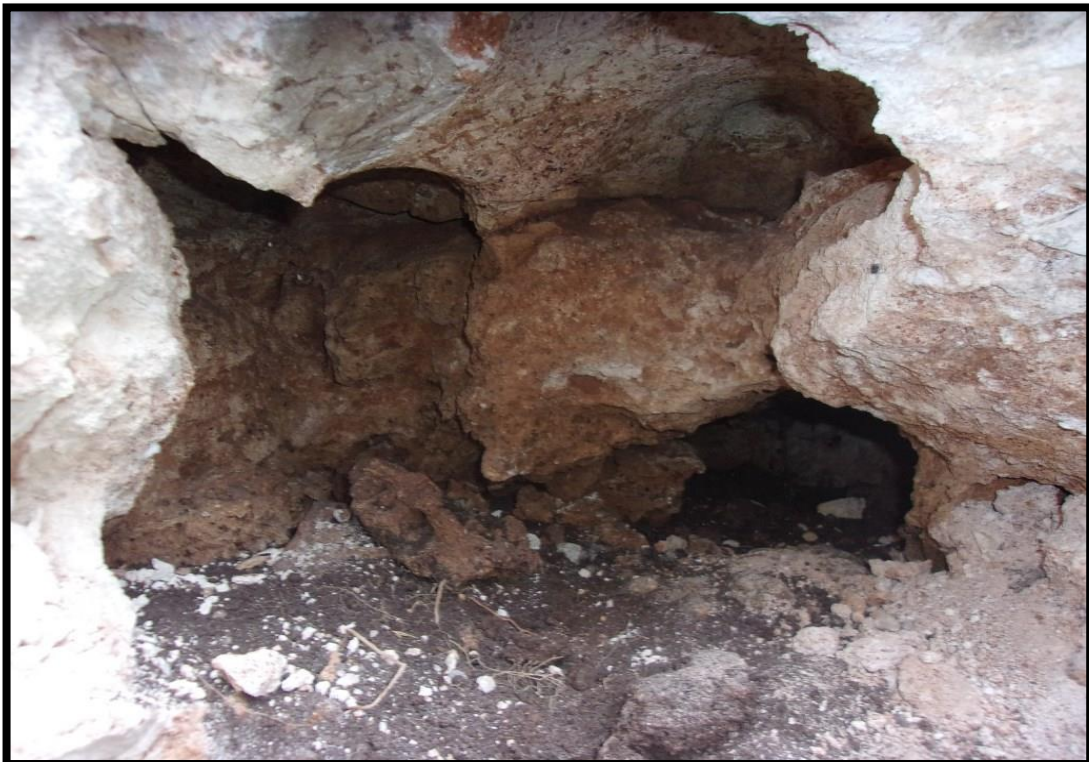
Photo 6. Feature S-8 opening at base of the excavation along the bedding contact. The feature is partially infilled with terra rossa clay.

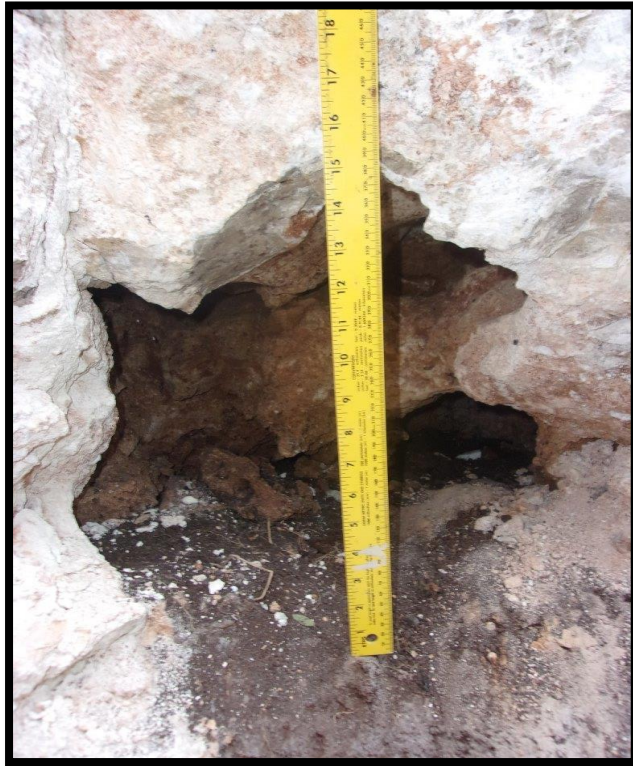
Photo 7. Feature S-8 vertical dimensions (14 inches) of the horizontal solution cavity in the excavation sidewall.

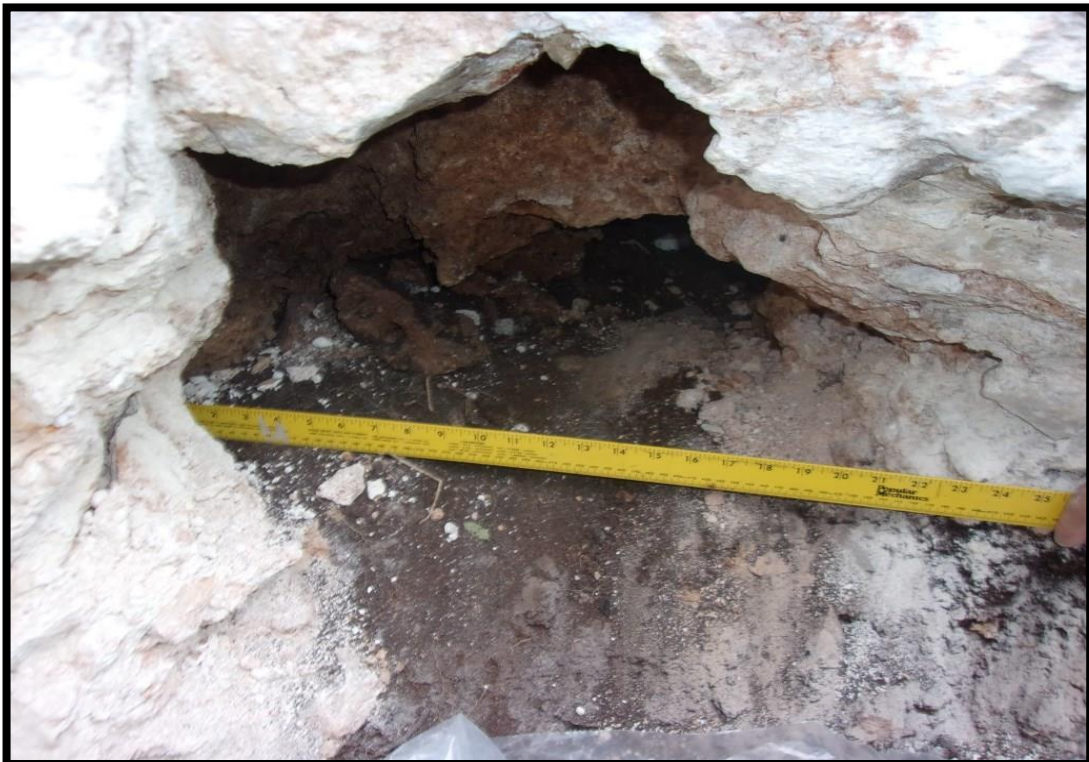
Photo 8. Feature S-8 horizontal dimension (21 inches) of the horizontal solution cavity in the excavation sidewall.

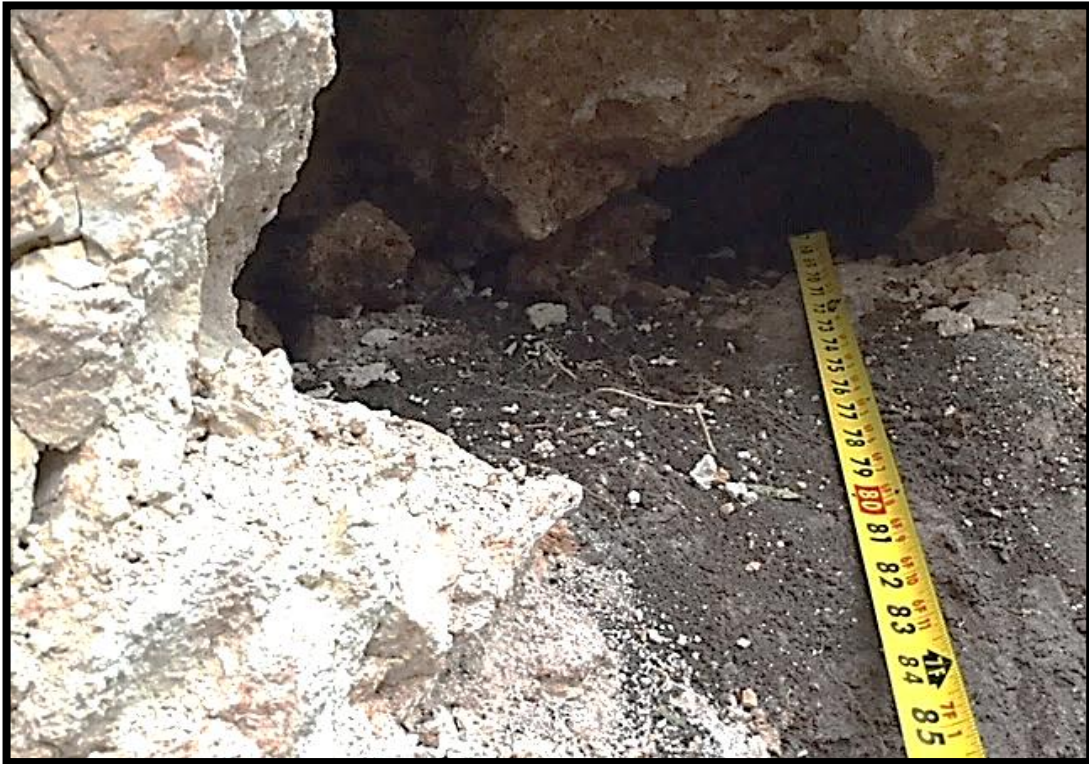
Photo 9. Feature S-8 maximum horizontal extent (approximately 7 feet) of the horizontal solution cavity along the long axis.

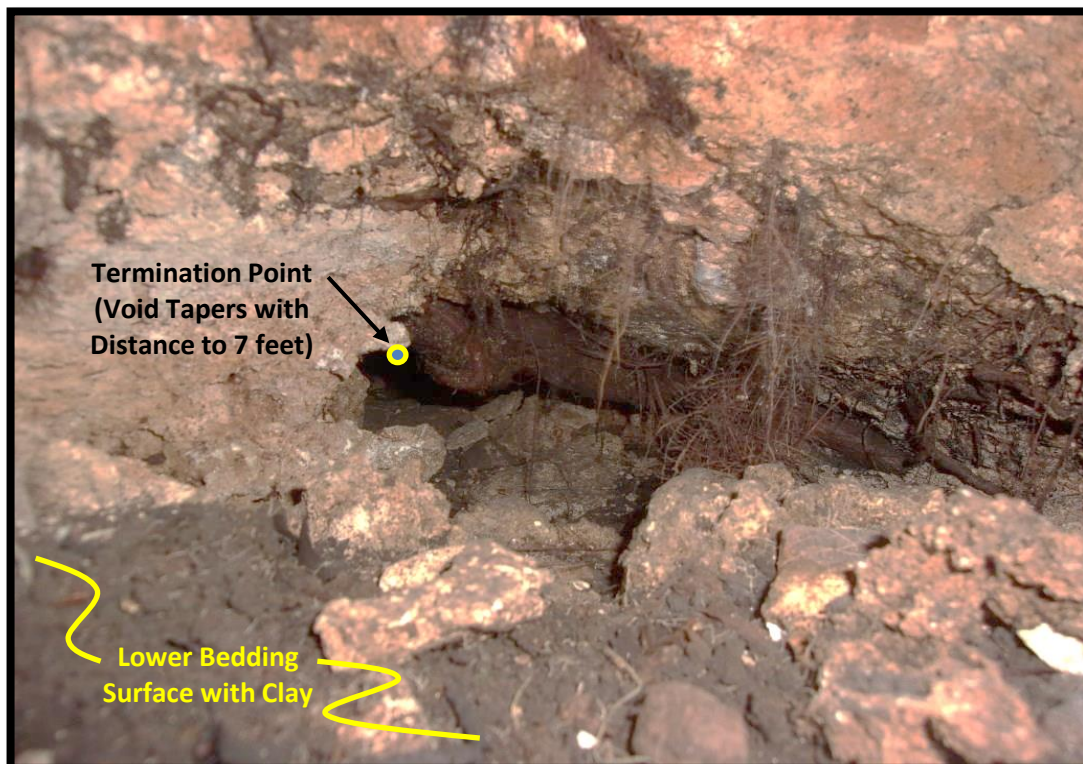
Photo 10. View of horizontal void space (Feature S-8) taken from inside the aperture.

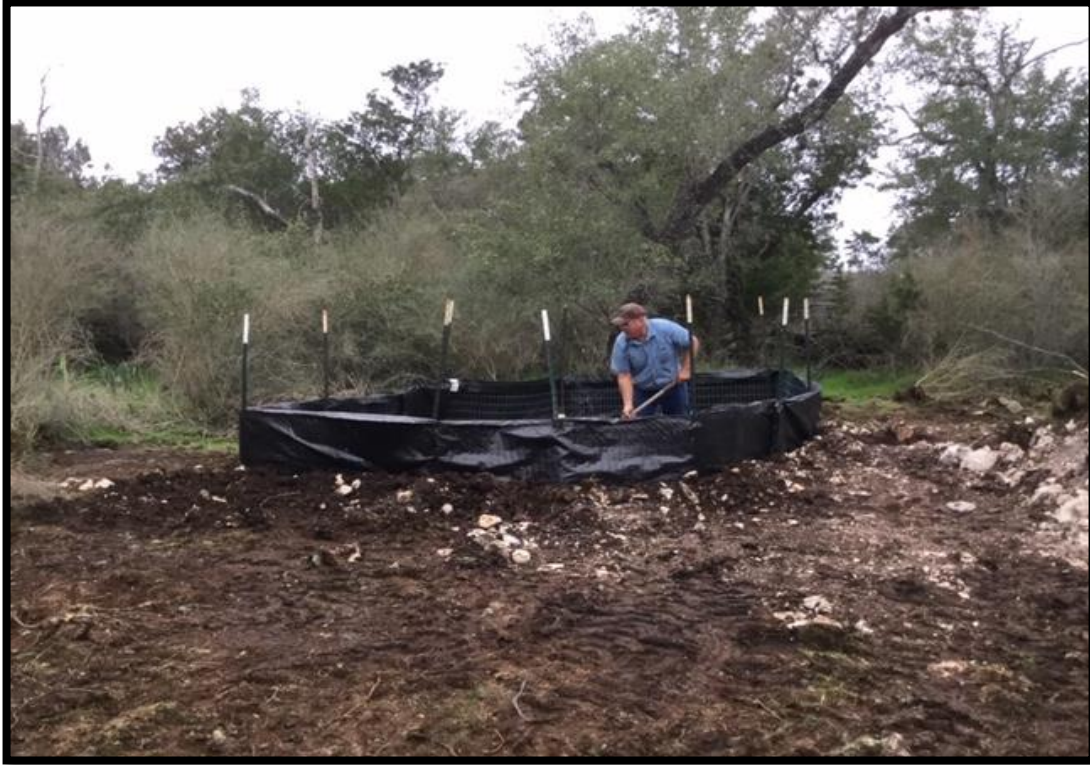
Photo 11. Silt-fencing placed around Features S-7/S-8 excavation site.

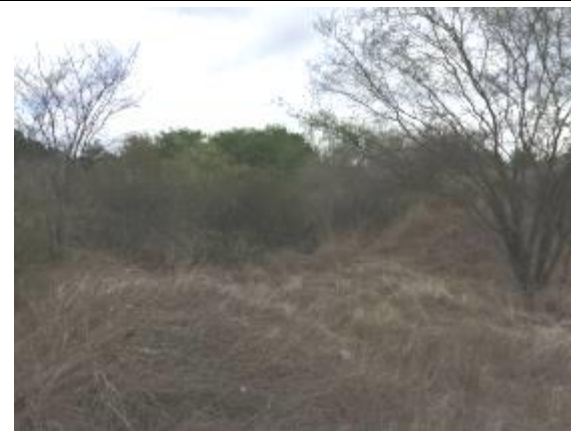
View to the southwest of gravel/soil stockpiles near the central portion of the SITE.

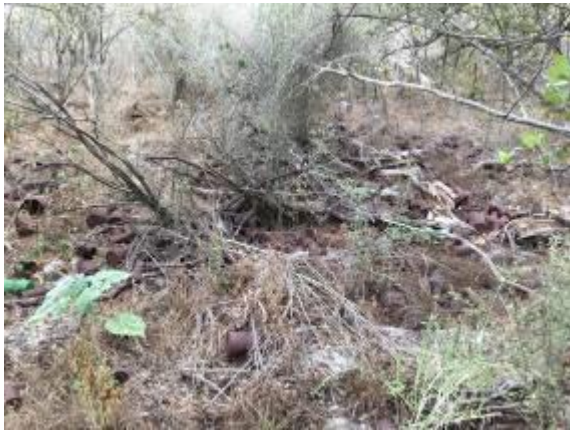
View to the south of an old burn pile in the central portion of the SITE.
