**RE: Evaluation of Karst Feature (S-8)
Solution Feature Discovery Notification
Village at Gruene Condominiums
New Braunfels (Comal County), Texas
Regulated Entity ID No. RN110919453**

SITE AND FEATURE LOCATION MAP VILLAGE AT GRUENE CONDOMINIUMS EAST OF GRUENE ROAD AND EWELLING LANE NEW BRAUNFELS, COMAL COUNTY, TEXAS REGULATED ENTITY No. RN 110919453

FEATURE PLAN AND PROFILE
VILLAGE AT GRUENE CONDOMINIUMS
NEW BRAUNFELS, COMAL COUNTY, TEXAS
REGULATED ENTITY No. RN110919453

**PROPOSED KARST FEATURE
PROTECTION PLAN**
VILLAGE AT GRUENE CONDOMINIUMS
NEW BRAUNFELS, COMAL COUNTY, TEXAS
REGULATED ENTITY No. RN110919453

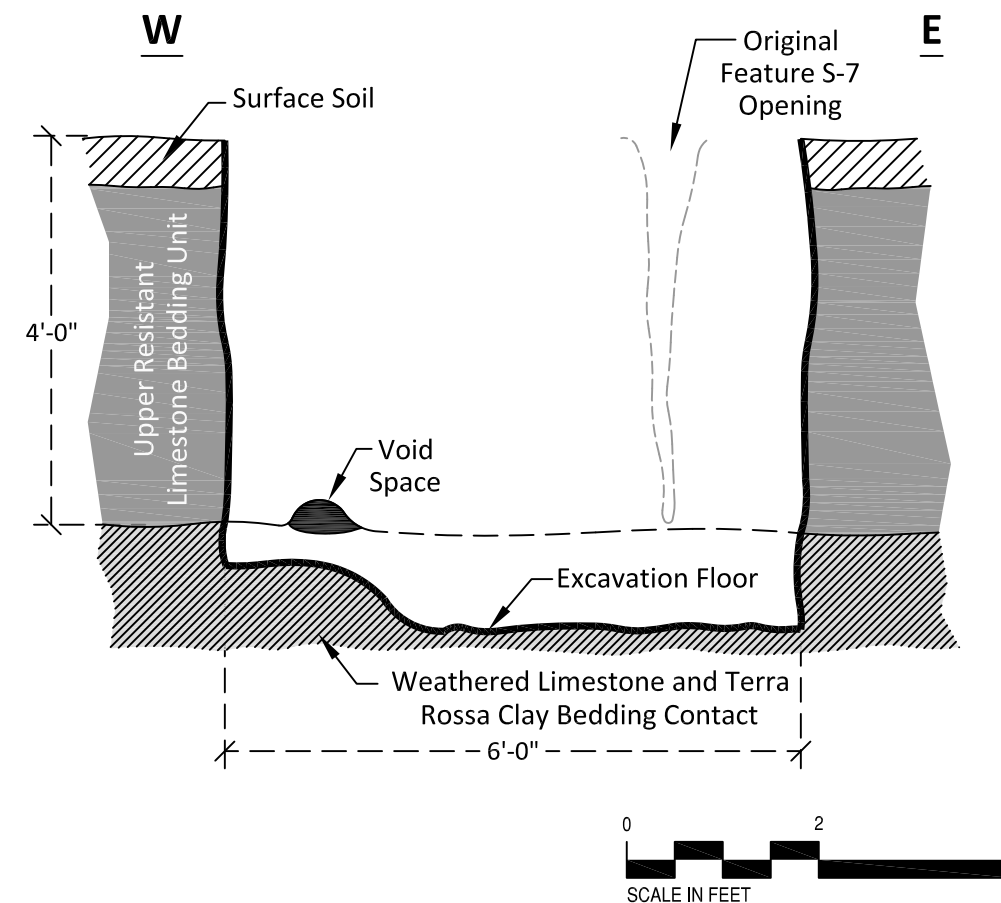
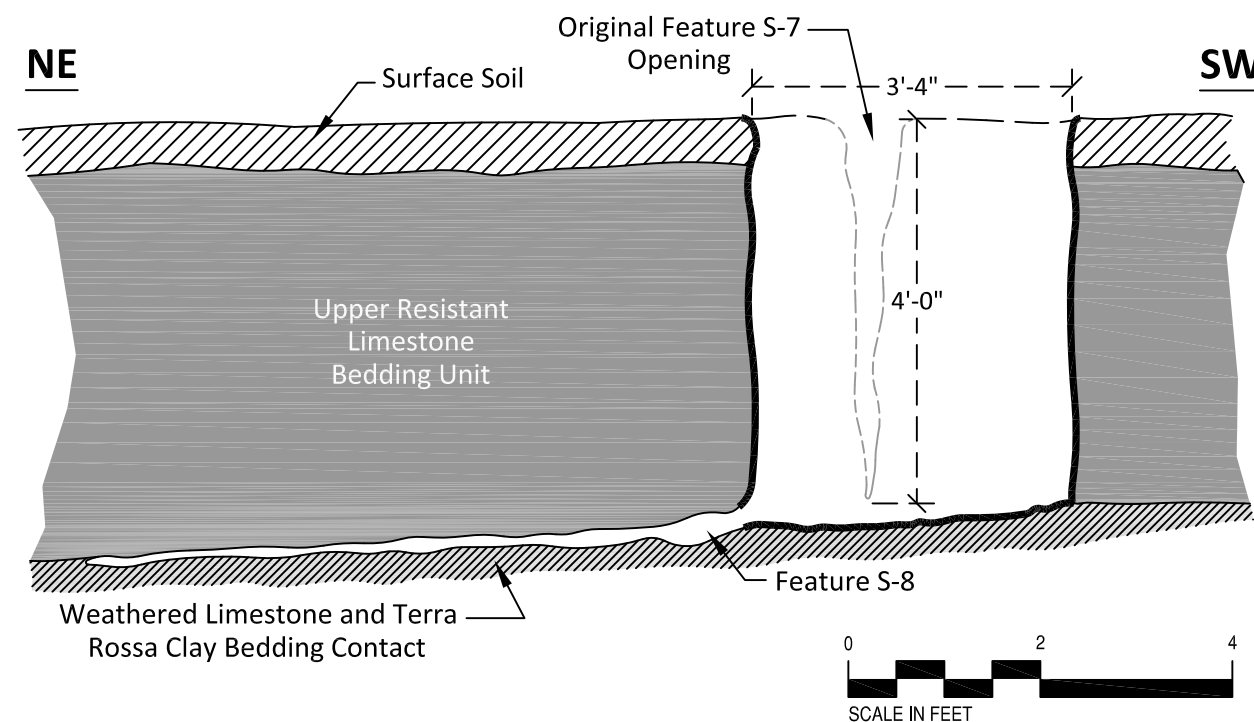
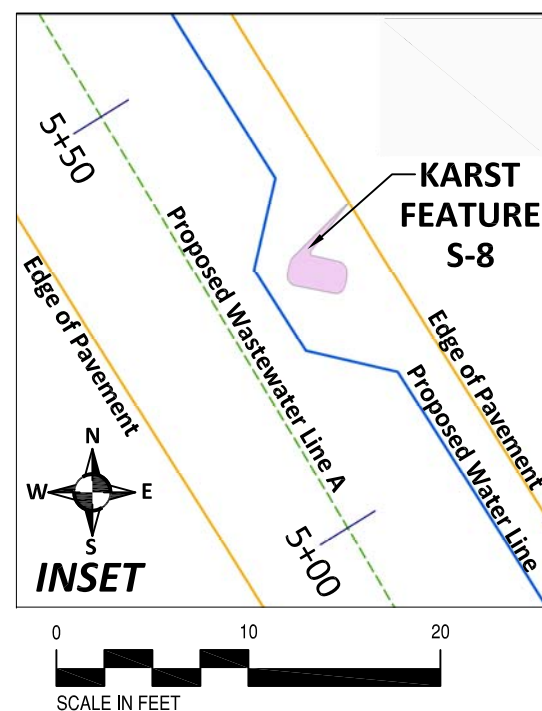
FEATURE PLAN AND PROFILE

Feature plan and profile sketches that depict the locations and dimensions of solution cavity features relative to proposed SITE improvements are provided as **Attachment 1B**. Photographs taken in conjunction with assessment activities initiated on February 18, 2020 are provided as **Attachment 1C**.

As depicted on the attached drawing (**Attachment 1B**), the referenced solution feature is located within the proposed roadway corridor for the land development project. It is our understanding that 2-3 feet of surface grading will generally be necessary to achieve the proposed elevation for the placement of road base. Based on information provided by the project design engineer (HMT Engineering and Surveying), approximately 3.07 feet of excavation is necessary at this location. Considering this, the specific protection procedures are summarized as follows:

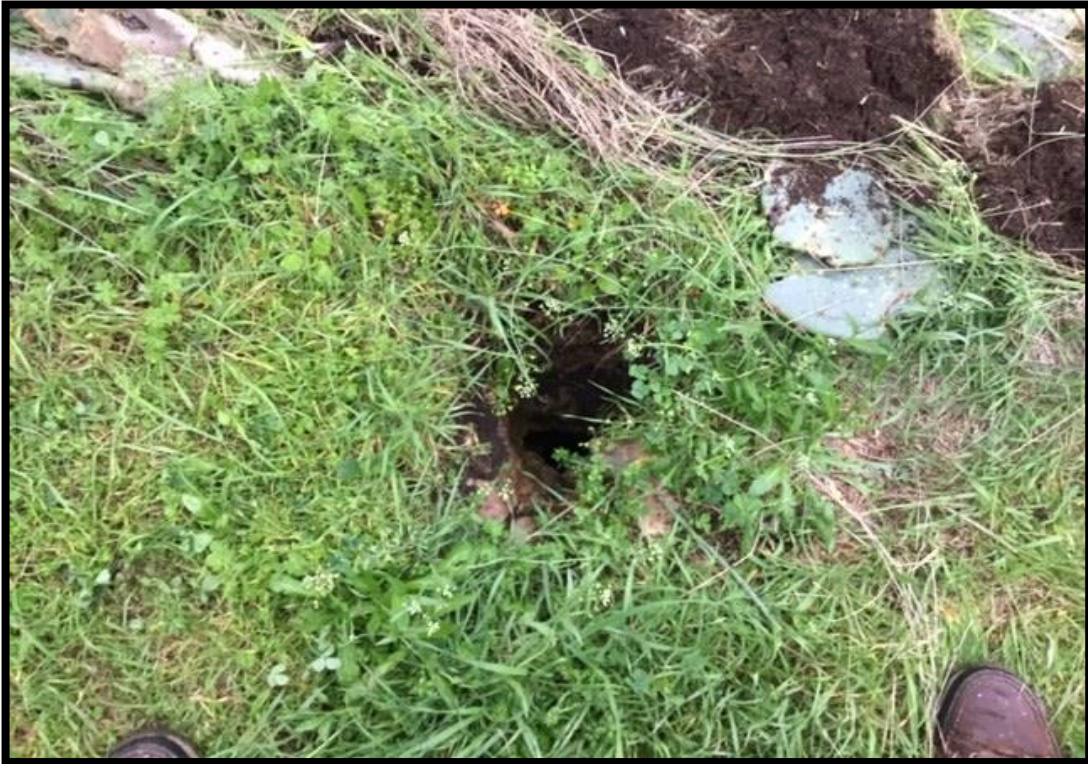
Feature S-7 consisted of a small-diameter vertical solution cavity that extended approximately 4 feet into the underlying Person Formation. No surface expression was evident during the initial October 2019 assessment, but this feature appears to have developed a surface connection in association with subsequent rainfall events. Results of an initial assessment conducted on January 31, 2020 indicated that the feature appeared to taper with depth, but it was not possible to determine its complete vertical extent. Surface soil with grass was present at the base of the feature, which confirmed recent collapse of soil cover. This feature was initially classified as potentially sensitive owing to its inferred karst origin, connection to underlying limestone, and inferred potential for rapid infiltration. Although classified as sensitive, it was not considered to represent a significant recharge feature, however, owing to its small size, lack of established drainage, and very small upgradient catchment area.

Photo 1. View of Feature S-7 prior to excavation. Feature size is approximately 1 x 0.8 x 4 feet in length, width, and depth, respectively.

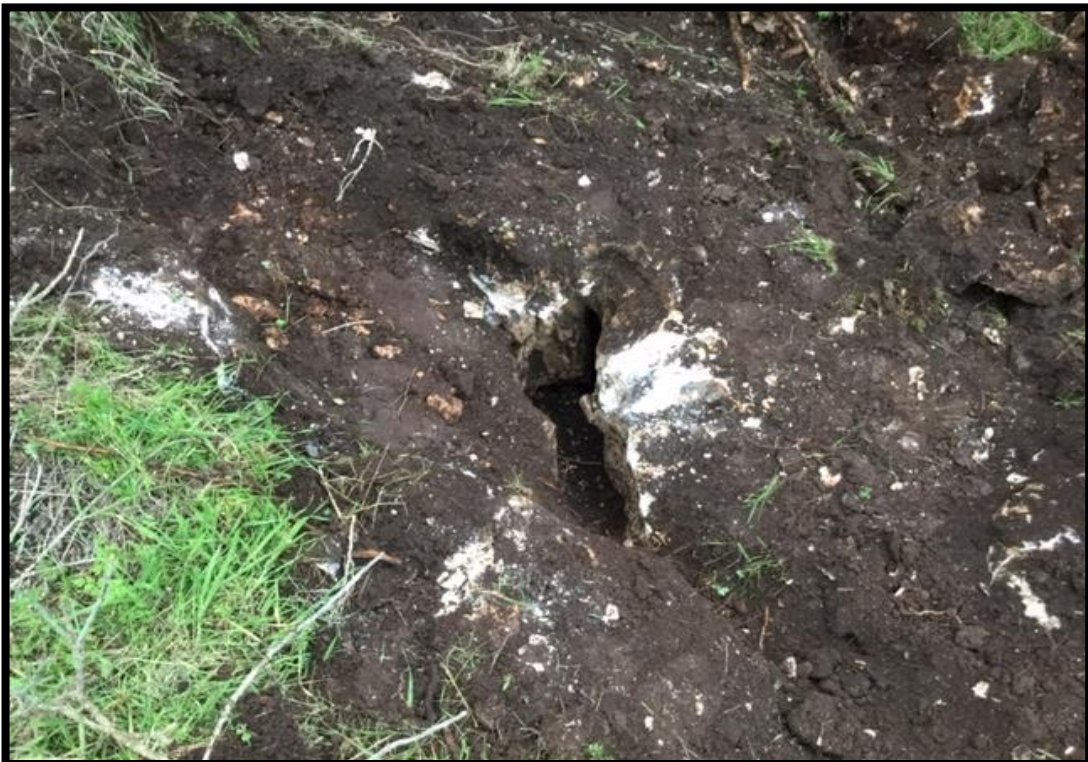
Photo 2. Top of limestone bedding unit at Feature S-7 following removal of soil and vegetation.

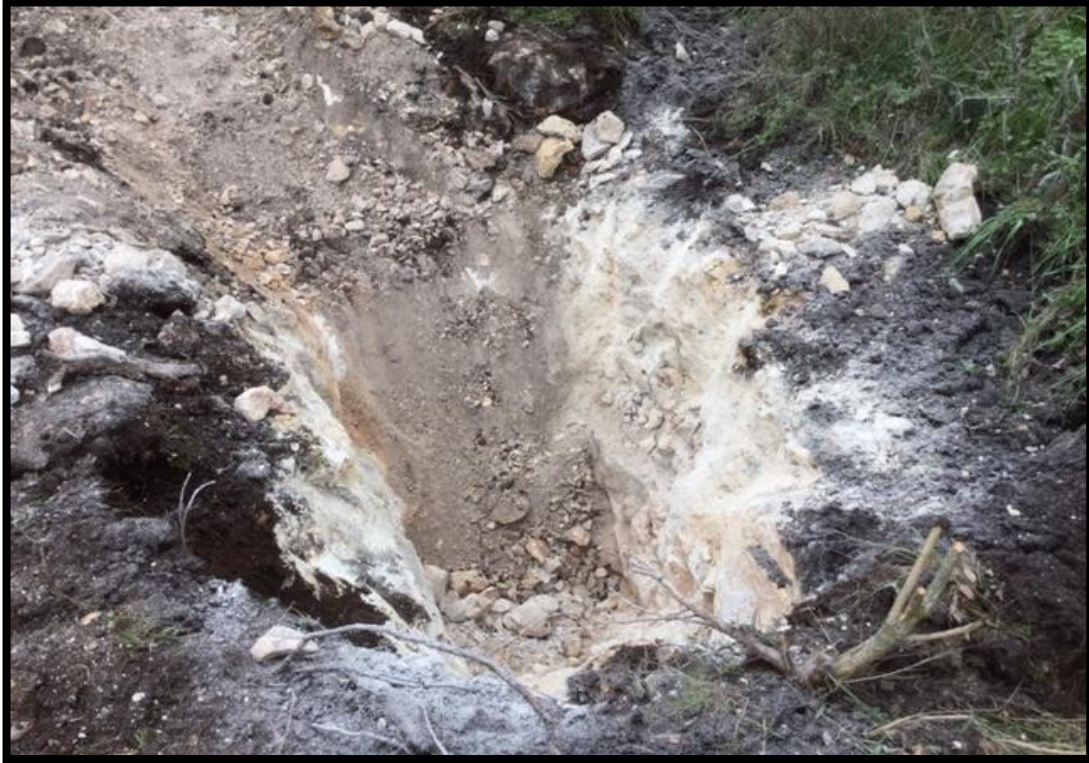
The project owner subsequently elected to further assess feature sensitivity in accordance with established EAPP protocols (i.e., Phase II assessment) to determine whether a significant hydrologic connection to the subsurface existed at this location (i.e., feature serves to transmit recharge directly to the subsurface). Following TCEQ approval of a work plan request submitted on February 12, 2020, excavation activities were subsequently conducted on February 18, 2020 using heavy equipment (backhoe excavator) to further assess the sensitivity of the feature and potential for connection to a larger subsurface void space. The vertical solution cavity was confirmed to extend through an uppermost (very resistant) bedding unit and terminate at a depth of approximately 4 feet at its lower bedding contact. The original vertical solution cavity was fully removed as the result of excavation activities.

Photo 3. Excavation at Feature S-7 in progress through the resistant upper bedding unit of the Person Formation (Cyclic and Marine member).

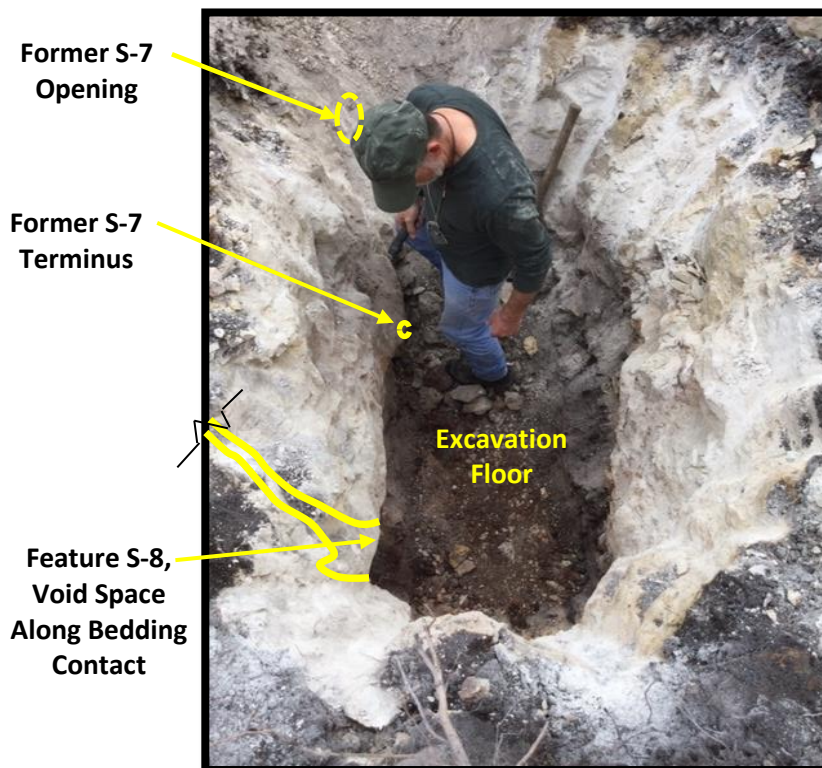
- The solution cavity appears to have been formed in association with surficial erosional processes and tree root activity. Tree roots were encountered during the excavation process.
- The feature was found to terminate at the bedding contact and did not exhibit direct connection to any larger karst openings or subsurface void space.
- Although the bedding contact was observed to be highly weathered, with iron-staining and evidence of dissolution, the majority of the dissolution openings throughout this zone of weathering were partially to completely infilled with red “terra rossa” clay soil and scattered tree roots.
- There is no well-defined drainage or channelization of surface flow to the feature. The feature did not contribute significant recharge to the subsurface.

Photo 4. Final excavation extent. Feature S-7 is completely removed and was determined to be terminated at the weathered limestone contact zone (excavation floor).

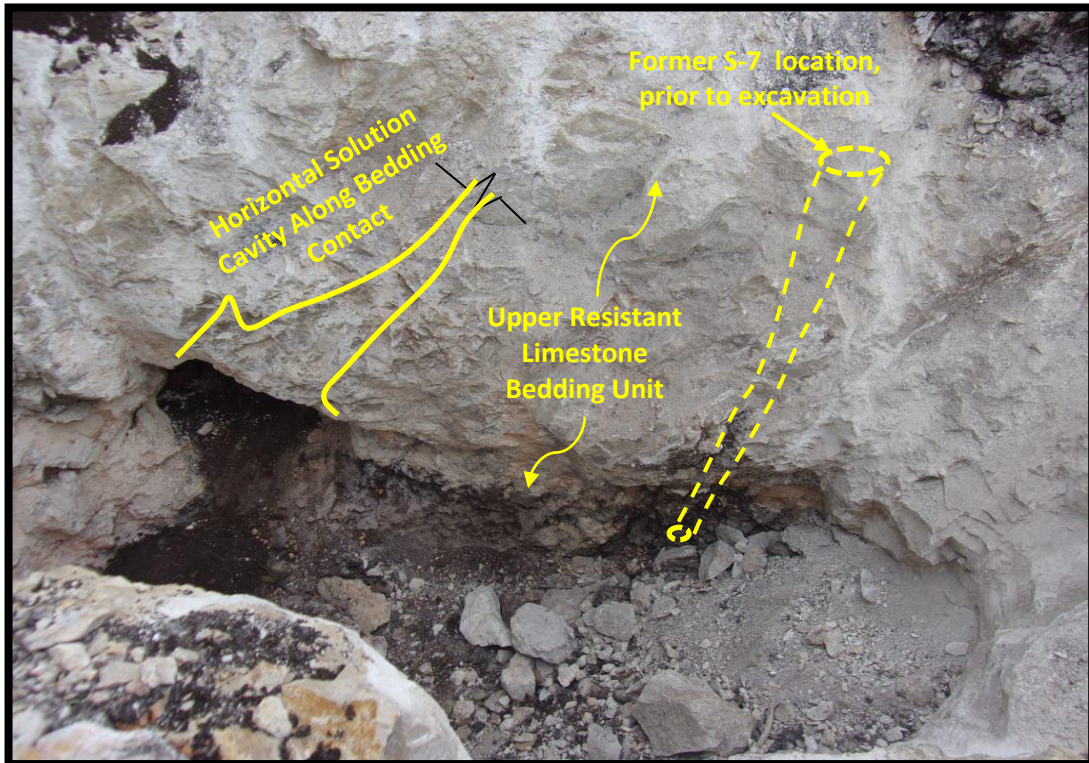
Feature S-8. In conjunction with vertical excavation efforts that extended slightly (i.e., 1-2 feet) below the termination point for **Feature S-7** through the weathered bedding-unit contact zone, a separate horizontal void space (solution cavity) was observed at the northwest corner of the excavation trench. The aperture was measured at approximately 21 x 14 inches and confirmed to extend approximately 7 feet along the contact zone at an orientation of 29° (NE-SW). The feature is localized in nature and does not connect to the south or west excavation walls. The floor of the horizontal solution cavity area was observed to be comprised of clay soils. The thickness of the soils along the bedding contact is estimated to be about 1.5 to 2 feet based on excavation activities within the exploration trench. The solution cavity opening was directly observable and found to taper with distance away from the excavation site (trench). The lateral boundaries of the solution cavity area are irregular and comprised of weathered (in-place) limestone and terra rossa clay.

Photo 5. Overview of Feature S-8 opening at base of the bedding contact. Floor of the excavation consists of the weathered contact zone with abundant terra rossa clay infilling.

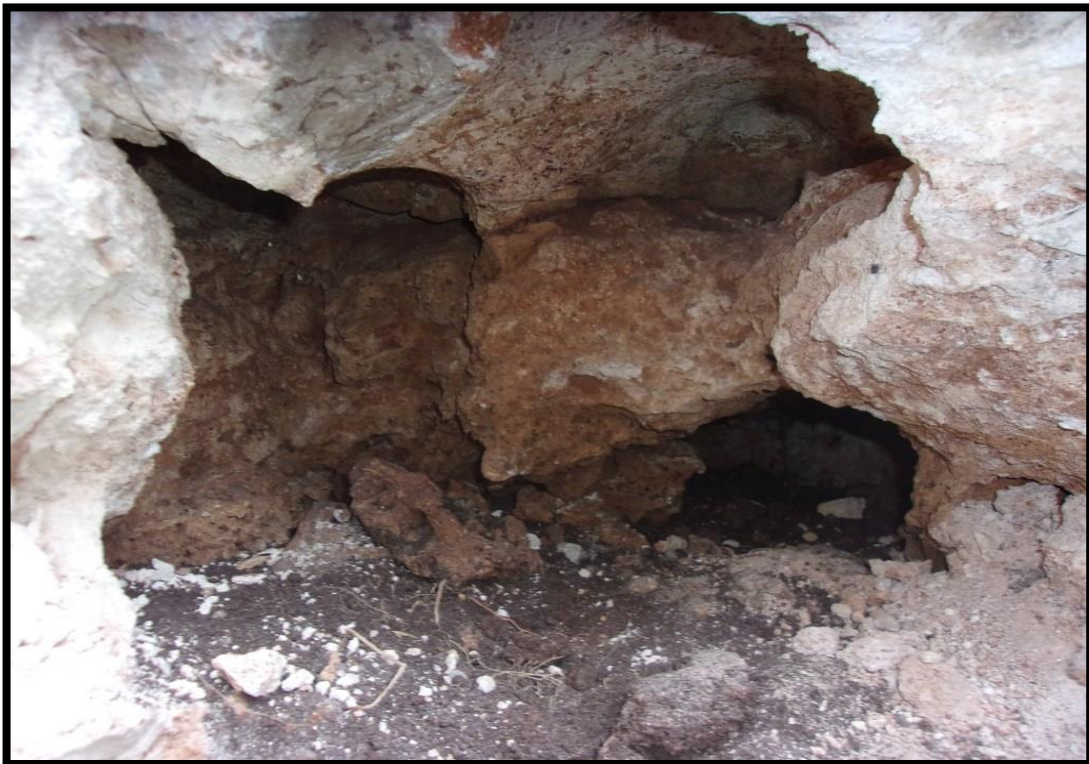
- The solution cavity is localized and appears to have been formed by dissolution along the limestone bedding-unit contact zone. The contact zone that hosts the feature is partially to completely infilled with red terra rossa clay soils, which typically facilitate the retention of subsurface soil moisture.

Photo 6. Feature S-8 opening at base of the excavation along the bedding contact. The feature is partially infilled with terra rossa clay.

1. Prior to commencement of SITE grading activities, the aperture of **Feature S-8** will be filled approximately 1 foot into the solution cavity by hand placement of washed No. 57 coarse limestone aggregate (1 inch to No. 4 sieve size) as defined per ASTM C33/C33M. The portion of the feature excavation corresponding to the weathered bedding contact will also be filled with washed aggregate to a minimum of 6 inches to 1 foot above the solution cavity opening.
2. Approximately 4 to 6 inches of concrete, with a minimum strength of 2,500 psi, will be placed on top of the aggregate and allowed to cure at least 24 hours prior to resuming any construction operations at or surrounding the feature location
3. Implementation of these protective measures will be monitored and approved by the project geotechnical engineering firm.

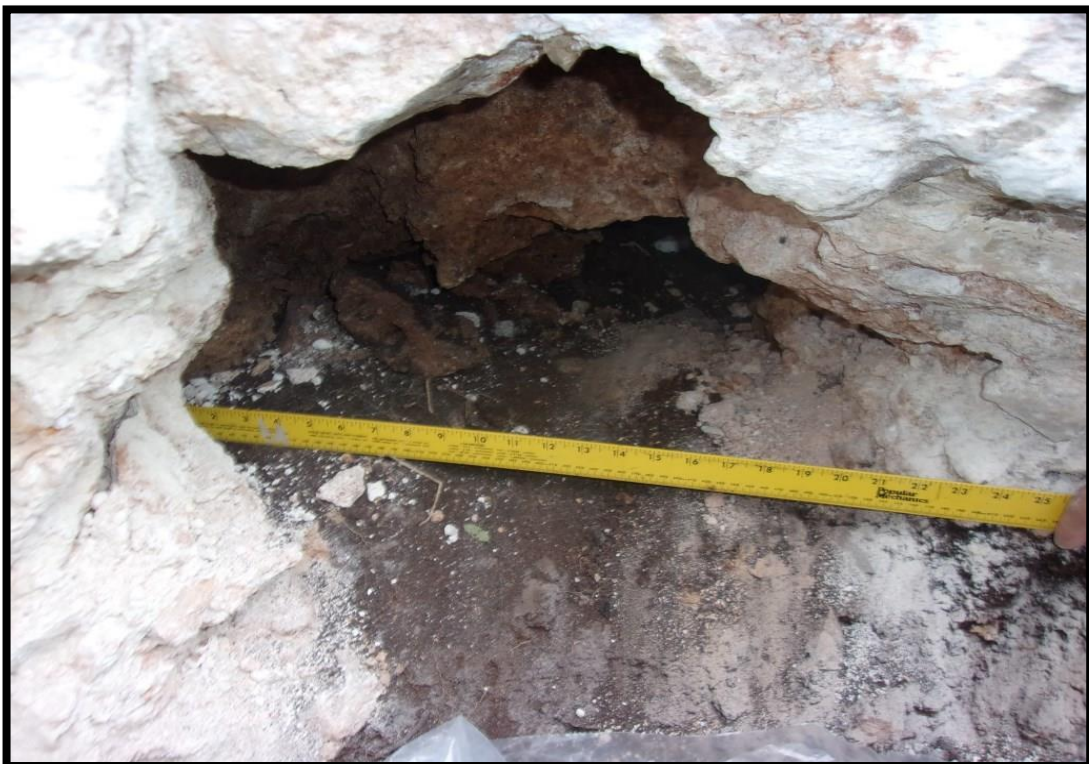
Photo 8. Feature S-8 horizontal dimension (21 inches) of the horizontal solution cavity in the excavation sidewall.

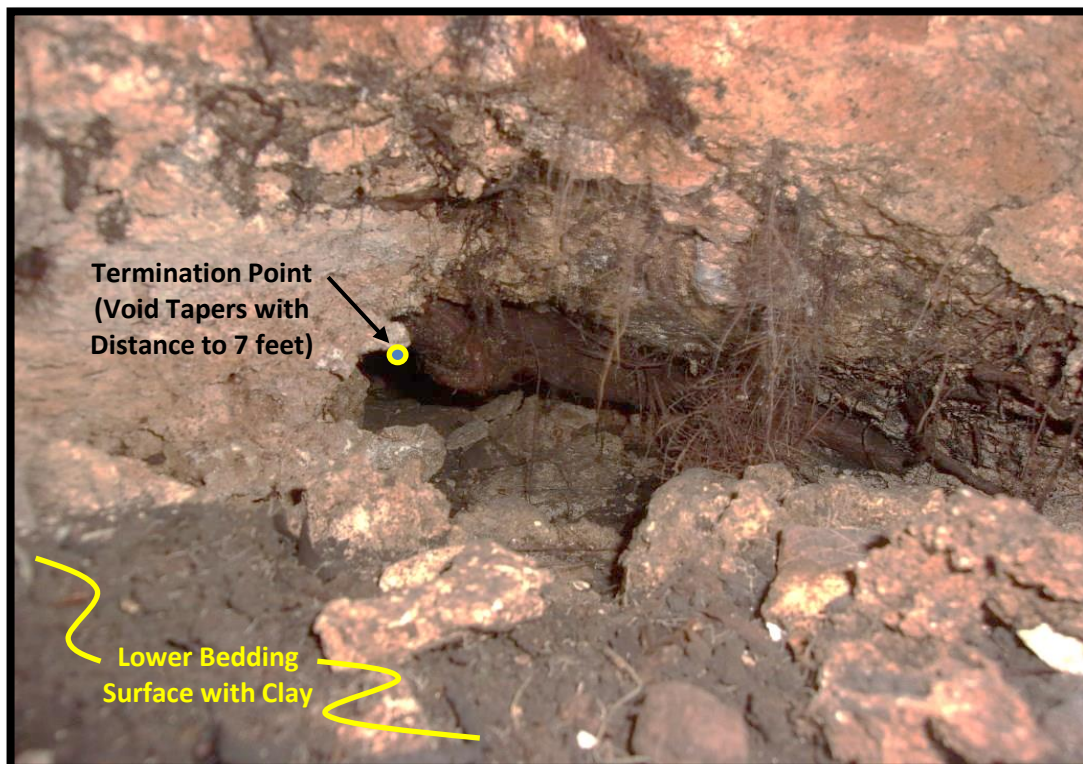
- As tree roots were present within the solution cavity void space and surrounding walls, it appears that the feature (and the larger bedding unit contact zone) has been exploited historically by tree root activity.

Photo 10. View of horizontal void space (Feature S-8) taken from inside the aperture.

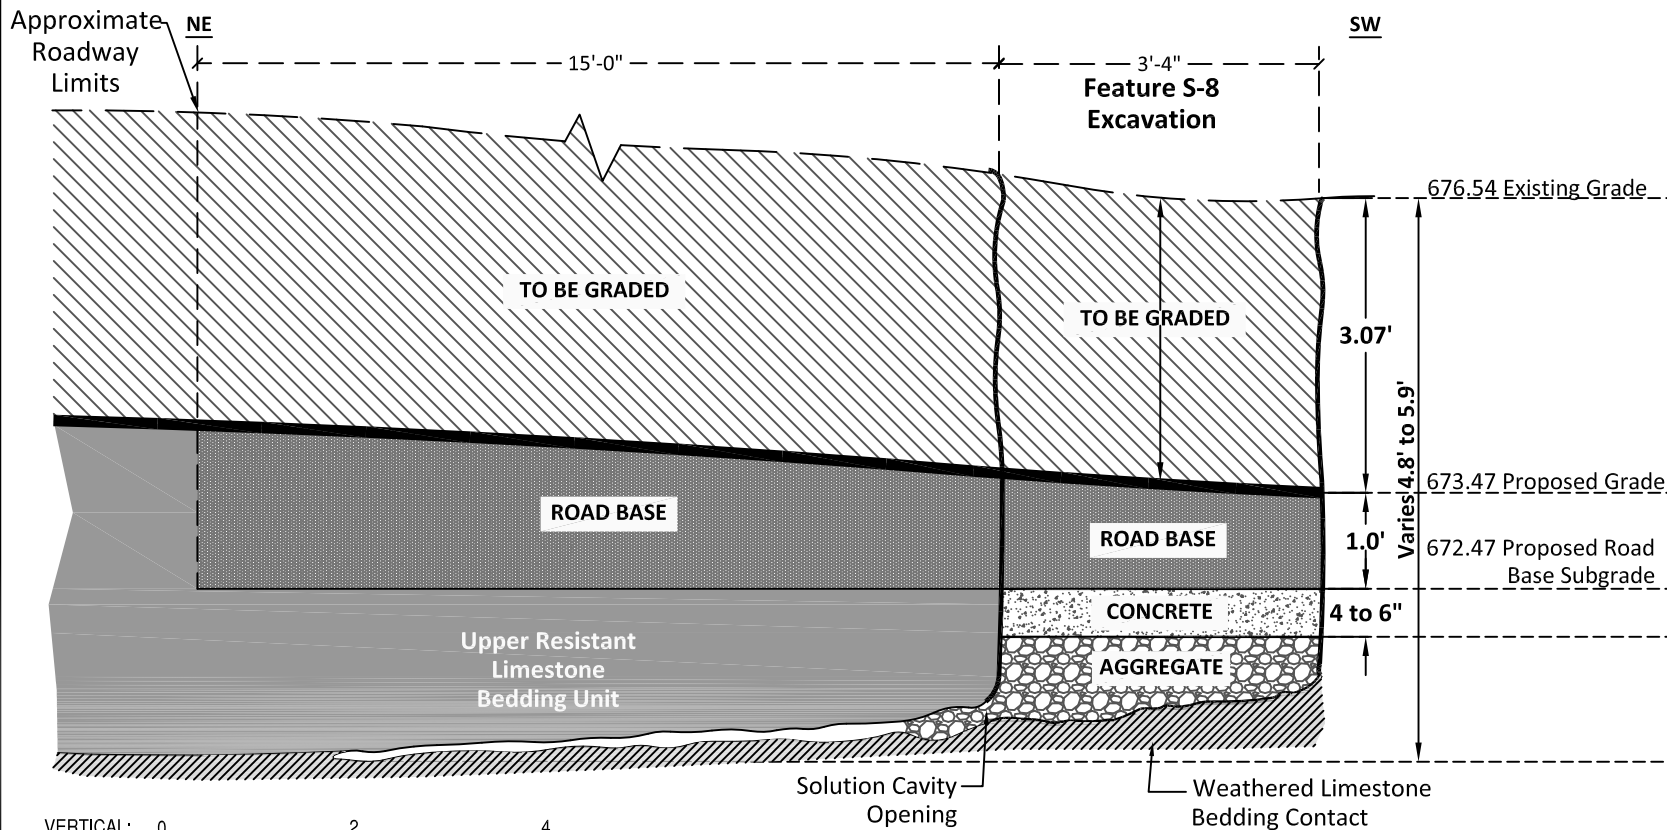
By following this protocol, it is anticipated that **Feature S-8** will be isolated from potentially contaminated water by the referenced concrete placement, yet still maintain its subsurface flow capability.

1. Prior to commencement of site grading activities, the feature aperture will be filled by hand to approximately 1 foot into the solution cavity opening with washed No. 57 coarse aggregate (1 inch to No. 4 sieve) as defined per ASTM C33/C33M. The portion of the feature excavation corresponding to the weathered bedding contact will also be filled with the washed aggregate to a minimum of 6 inches to 1 foot above the solution cavity opening.
2. Approximately 4 to 6 inches of concrete, with a minimum strength of 2,500 psi, will be placed on top of the aggregate and allowed to cure at least 24 hours prior to resuming any construction operations at or surrounding the feature location.
3. Implementation of protective measures will be monitored and approved by the project geotechnical firm.
